**Use of Copper-Nickel Cladding
on Ship and Boat Hulls**

CDA Publication No TN 36, 1985

Copper Development Association

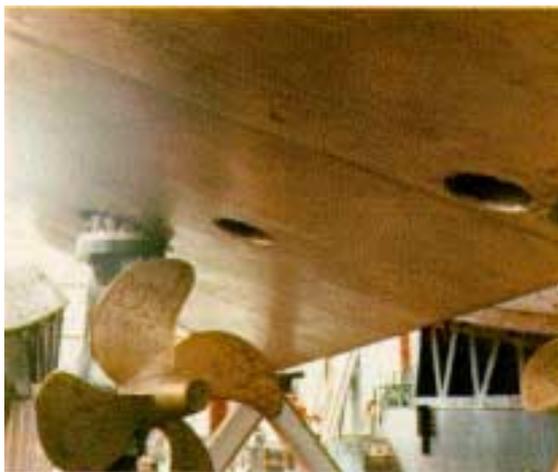
Figure 5 - Rudder propeller and water intakes

The seawater-carrying tubes in the boat are of conventional marine engineering design. Like the boat's hull, the seawater intakes for the cooling water, and for supplying the water cannons, are made predominantly of Cu/Ni-clad plate. They are closed off by aluminium bronze slide-gate valves G-CuAl10Ni (as per DIN 1714) or AB 2 (as per BS 1400). An electron-conductive connection between the successive metal parts of the construction was avoided by appropriately insulating the flanged joints on the intake and outlet sides of the slide-gate valves.

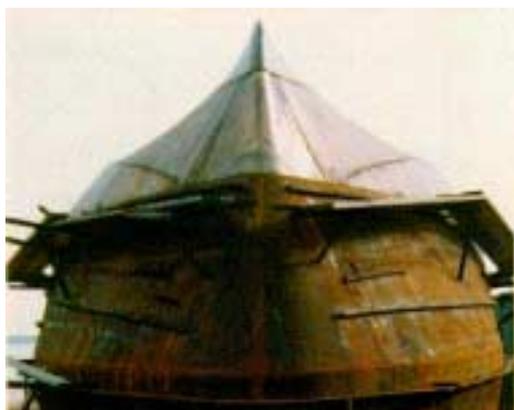
Figure 6 - Bow area in the process of being welded

Figure 6 shows the bow of one of the fire boats during the construction phase. The shape of the clad hull section, indicated by individual plates, was obtained by cold bending under shipyard conditions.

It can be seen from Figures 6 and 7 that the welding of the boat's hull also had to be performed in non-down-hand position. In doing so, particular attention had to be paid that as little iron as possible from the base material was diluted with the cladding materials so as not to adversely affect the corrosion behaviour in the weld region. Integral iron contents of between 3 and 5% in the CuNi30Fe weld metal were assessed to be largely uncritical [7,4].

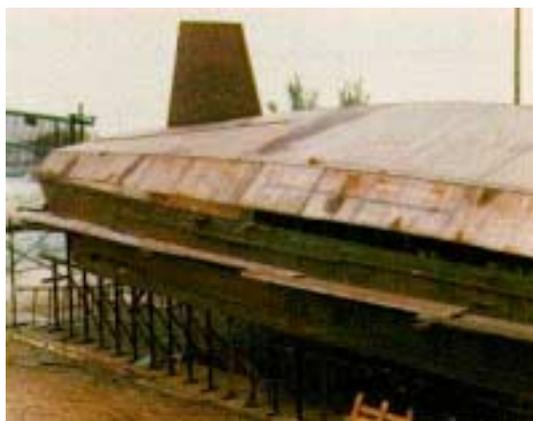
Figure 7 - View of a fire boat hull built of Cu/Ni-clad steel

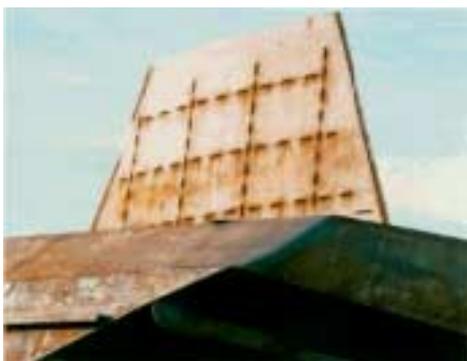
Figure 8 - Boat stabilizing rudder sheathed on one side with 3 mm CuNi10Fe1Mn-sheet

Figure 8 shows a further design detail. One side of the stabilizing rudder was sheathed in CuNi10Fe1Mn sheet (3 mm). The joining technique was similar to that used to weld the clad material.

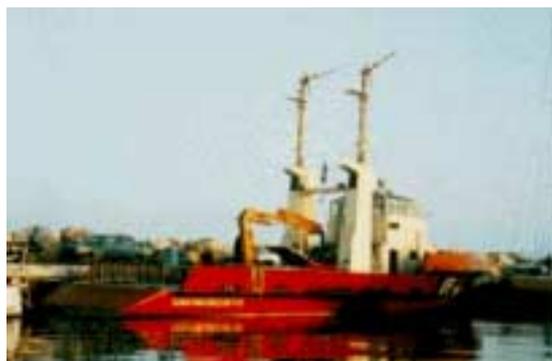
Figure 9 - Fire boat VF 541 "Sabatino Bocchetto" launched in November 1984

Before commissioning of the vessel, all of the welds were ground to give the boat's hull an optimally low friction resistance. Figure 9 shows the first of the fire boats, VF 541 "Sabatino Bocchetto", shortly after its launch at the beginning of November 1984. It can be seen that the topsides are conventionally coated. The coating slightly overlaps the clad zone, the latter extending some 100 mm above the waterline.

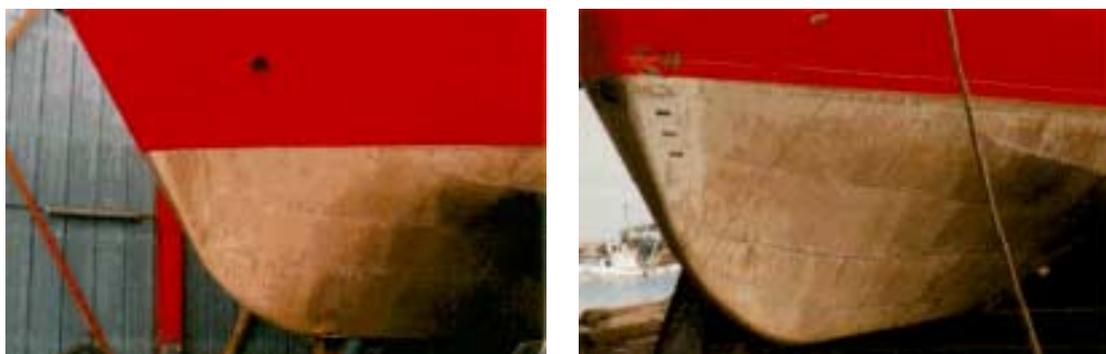
Figures 10a and b - Bow area in Cu/Ni clad steel before launching (a) and after 2.5 months in service in the Adriatic (b)

After some 2.5 months in the Adriatic the first fire boat was put into dry dock again to undergo additional installation work. This provided the opportunity of inspecting all the parts of the ship constructed of Cu/Ni-clad material. With satisfaction it was found that the CuNi10Fe1Mn was totally devoid of fouling, as is shown in Figure 10. The CuNi30Fe-welds had a perceptibly darker colour. The welding zones of the sheathing on the rudder displayed the first signs of fouling, but this could be removed by light rubbing. The fouling on the coal tar epoxy coated parts of the rudder propellers, in contrast, proved to be more adherent (Figure 11). All of the additionally installed components, including the water intakes, were in perfect condition and without any signs of corrosion.
